Fire Performance of ASTM E119 Evaluation of Asymmetric MPP Load-Bearing Wall Assembly

*Indicative testing conducted in accordance with the test methodology
described in ASTM E119-24, Standard Test Methods for Fire Tests of
Building Construction and Materials*

**Freres Engineered Wood
PO Box 276
Lyons, OR 97058**

WFCi Report #25028

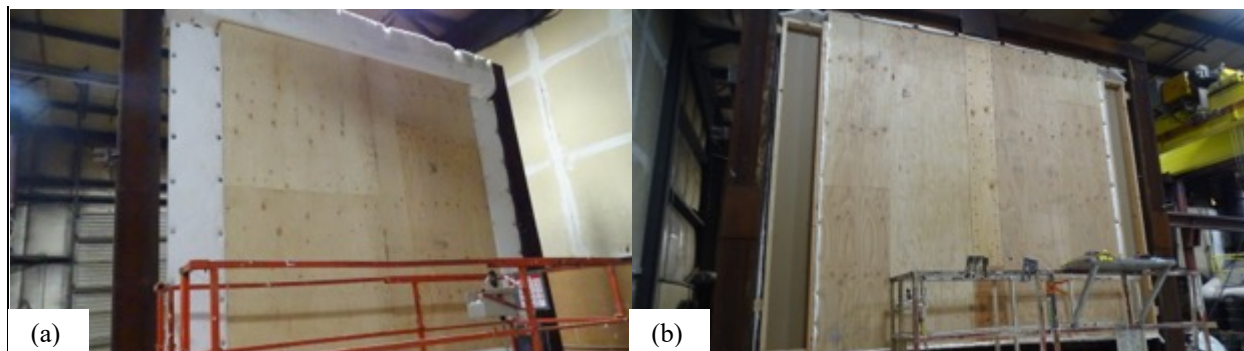
Figure 1. Representative MPP panels showing joined assembly (a) exposed side and (b) unexposed side with spline.

Two identical panels (10'×5') were sent for the test (Figure 1), each with a spline cutout section (1 $\frac{1}{16}$ "×6"). The two panels were joined together in the sample holder and tightened together without any caulk or additional protection. The spline (1 $\frac{1}{16}$ "×12") was installed on the unexposed side of the wall, consisting of two pieces, an upper 8' piece and a lower 2' piece. The spline was fastened to the main MPP wall with 3 $\frac{3}{8}$ " screws ($\frac{5}{16}$ " head, TrussTite) at 6" oc spacing, 2" from the long edge and 1" from the joint and top and bottom. With the spline and fasteners on the unexposed side only, this assembly is asymmetric, and was only tested in the configuration.

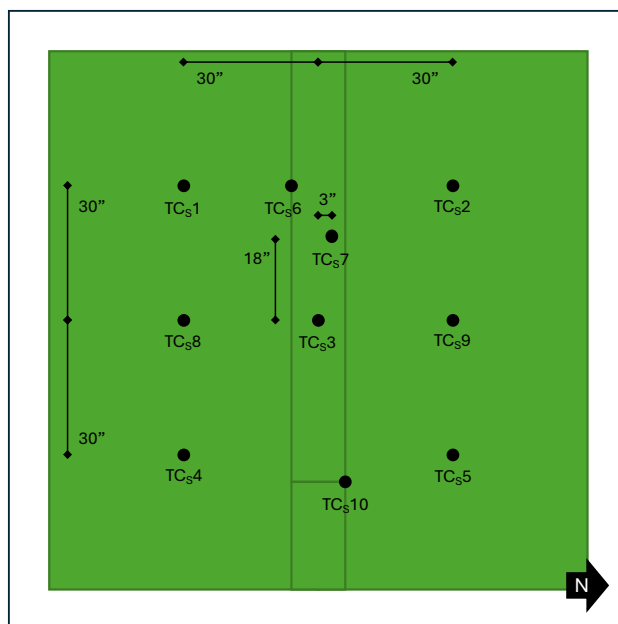
Figure 2. Wall schematic showing TCs layout

Sample thermocouples (TCs) were used to better describe temperature behavior for the load-bearing assembly. TCs locations are described below and in Figure 2:

- Unexposed (TCs1-10): Placed on unexposed surface of the panel. Each was covered with a 6"×6" dry ceramic fiber pad.

Individual groups were averaged together to give a general temperature rise through the assembly. Unexposed criteria outlined in the E119 test were judged from these data.

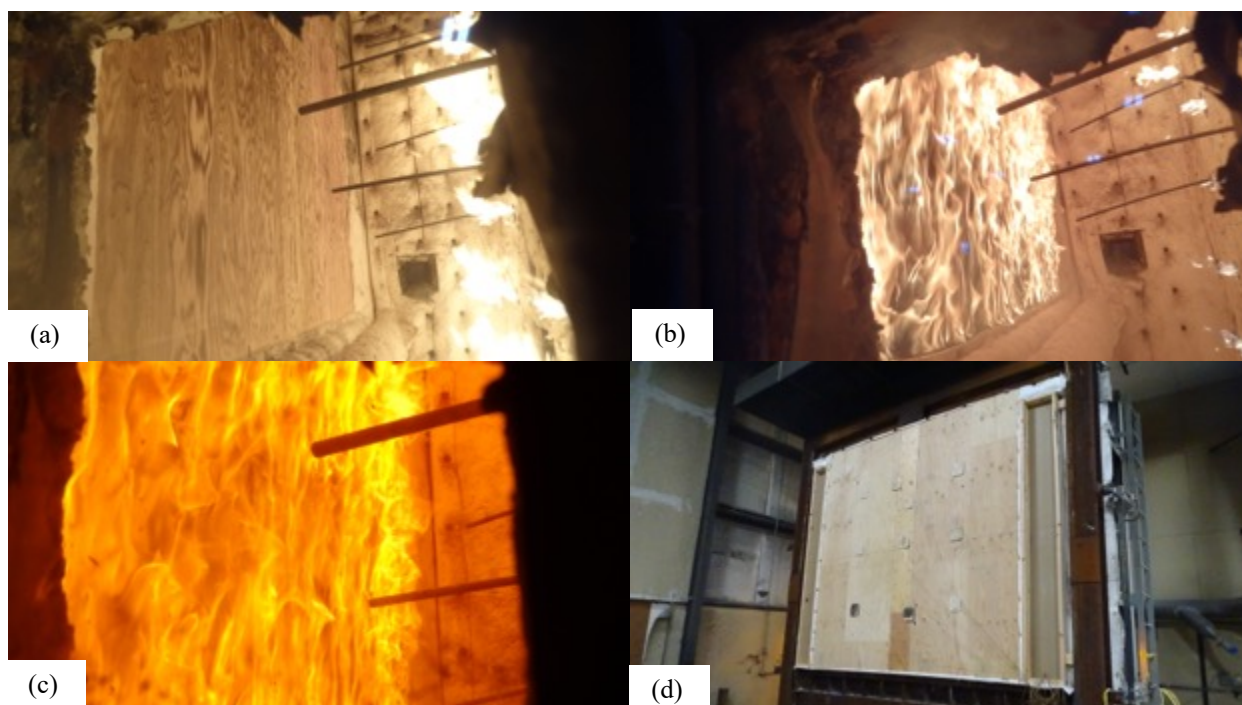
Figure 3. Test 1 wall assembly during fire resistance test showing (a) ignition – 1 min, (b) ignition – 2 min, (c) continued flames – 91 min, and (d) near end of fire endurance – 118 min.

Test Time (hr:mm:ss)	Event
00:00	Start test – 1507.6 psi
01:00	Darkening face
01:15	Flames on face
02:00	Periodic introduction of water to furnace to help control (approximately 5 min)
08:30	Charred layer of wood
1:15:30	Continued flames on face
1:31:00	Large pop from wall assembly
1:45:00	Another large pop – continued flames
1:58:00	Another large pop – continued flames
2:00:38	Furnace off – area under time-temperature curve met
2:03:23	Start hose-stream (30 psi)
~2:05:53	Stop hose-stream – no water projection Approximately 3” virgin wood remaining

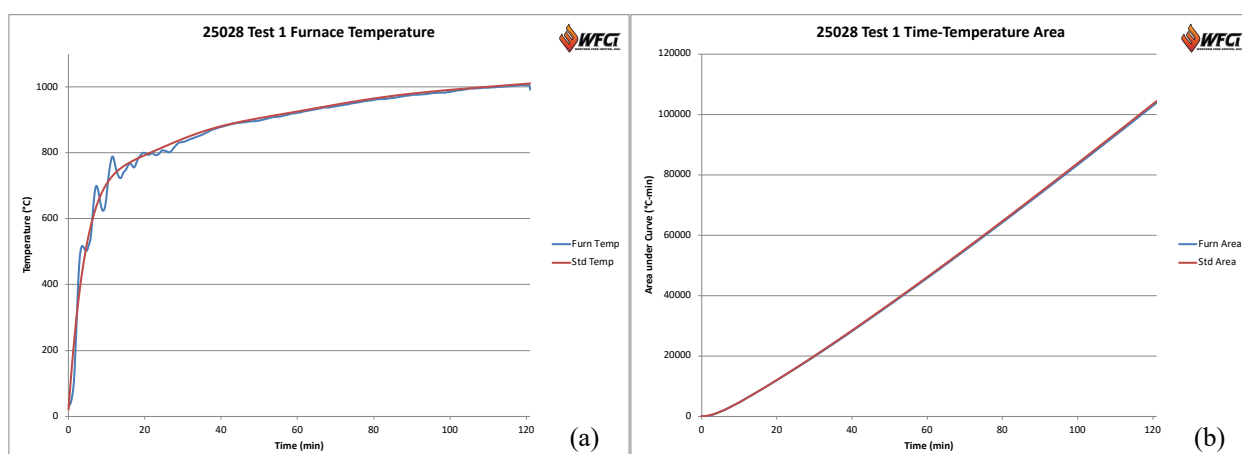
Figure 4. Test 1 furnace comparison with standard showing (a) temperature and (b) area under the curve.

The furnace temperature followed the standard time-temperature curve as shown in Figure 4a, which had some initial variation due to the intense burning of the wall. Addition of water at the bottom of the furnace helped better control the temperature the required time-temperature curve and only lasted approximately 5 min once started. A comparison of the area under the time-temperature curve with the standard is also shown in Figure 4b. The area (-0.5%) is within the 7.5% recommended for a 2-hr test.

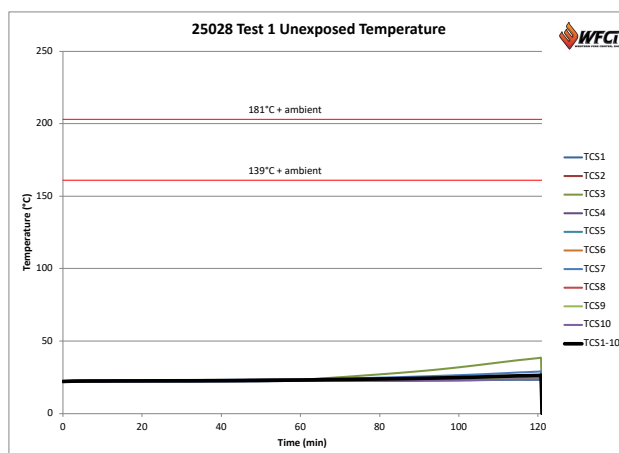
Figure 5. Test 1 sample thermocouples showing unexposed temperature.

Sample TC_s are shown in Figure 5 on the unexposed side of the assembly. The unexposed thresholds (139°C + ambient for average, 181°C + ambient for single-point) were not surpassed during the test with an average value 26°C, meeting the temperature requirements for a 2-hr test.

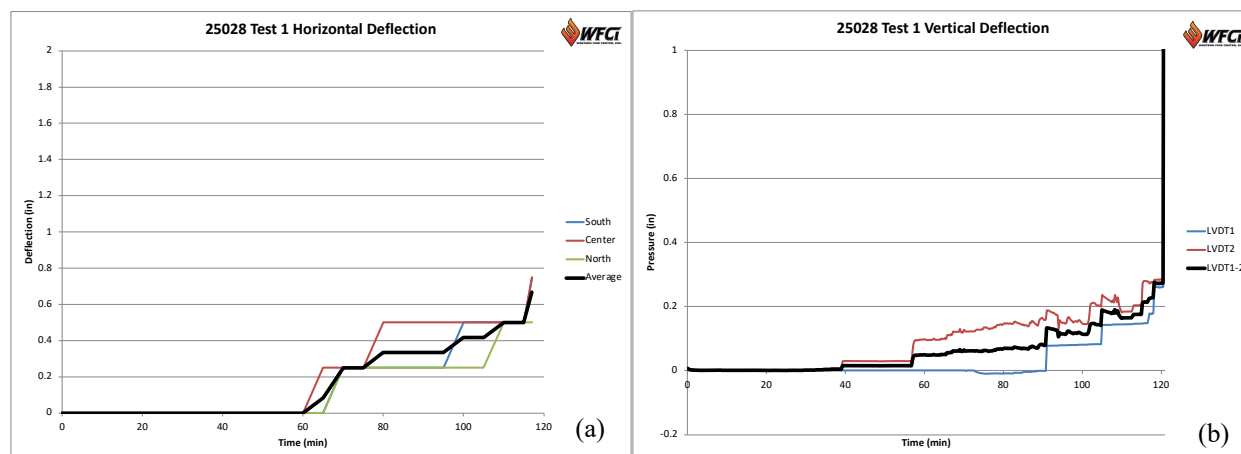
Figure 6. Test 1 showing (a) horizontal deflection and (b) vertical deflection.

Horizontal deflection measurements (Figure 6) were taken every five to ten minutes at three locations along the horizontal midline on the unexposed sample surface to monitor horizontal movement of the sample. The average horizontal deflection (away from the furnace) showed little difference for the first 60 min, but increased to an average value near $\frac{3}{4}$ " at the end of the test. The vertical deflection showed an average final value of deflection of approximately 0.27".

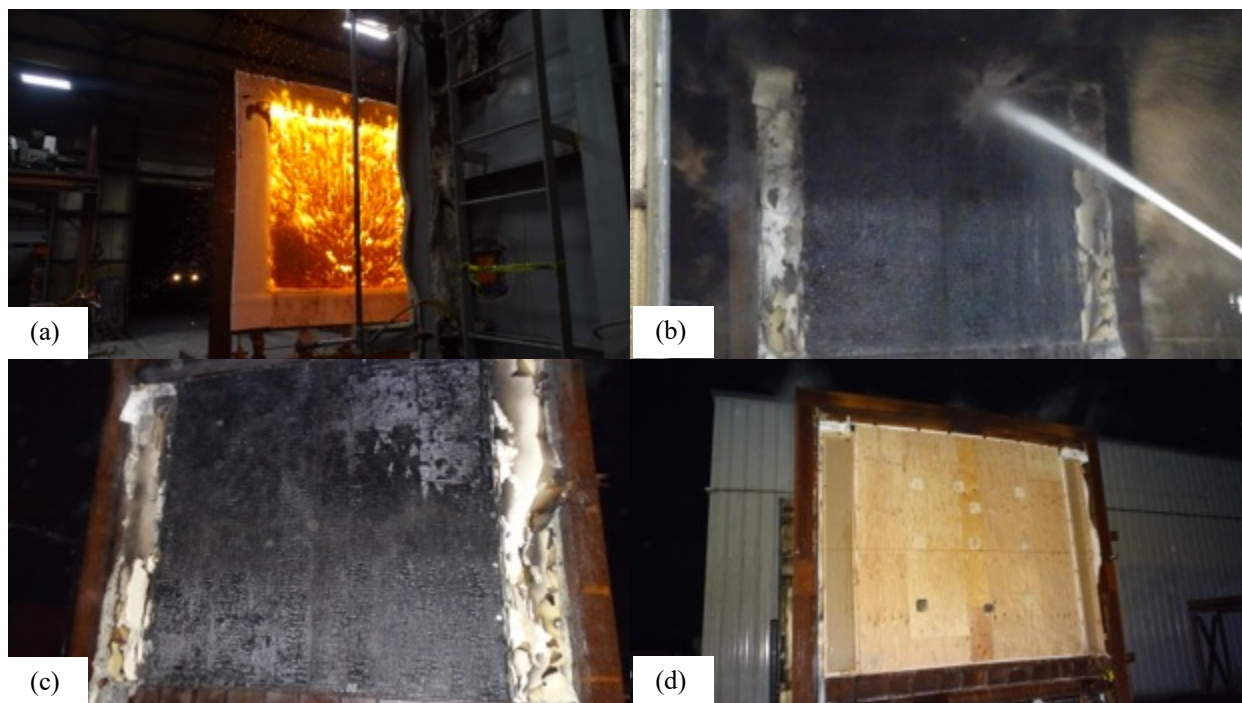
Figure 7. Test 1 showing (a) after fire endurance, (b) during hose-stream, (c) exposed side after hose-stream, and (d) unexposed side after hose-stream.

Directly following the fire resistance portion of the test, the assembly was backed away from the furnace to perform the hose-stream portion (Figure 7). For this portion, a water hose stream was applied at a pressure of 30 psi for 2 m 30 s ($2\frac{1}{2}$ min/100 ft² for 2-hr resistance, ASTM E2226-25, *Standard Practice for Application of Hose Stream*). Hose stream application began approximately 3 min following the removal of the assembly from the furnace.

No holes or penetrations developed in the assembly that permitted the projection of water from the hose-stream beyond the unexposed surface, thus fulfilling this hose-stream requirement of the standard.

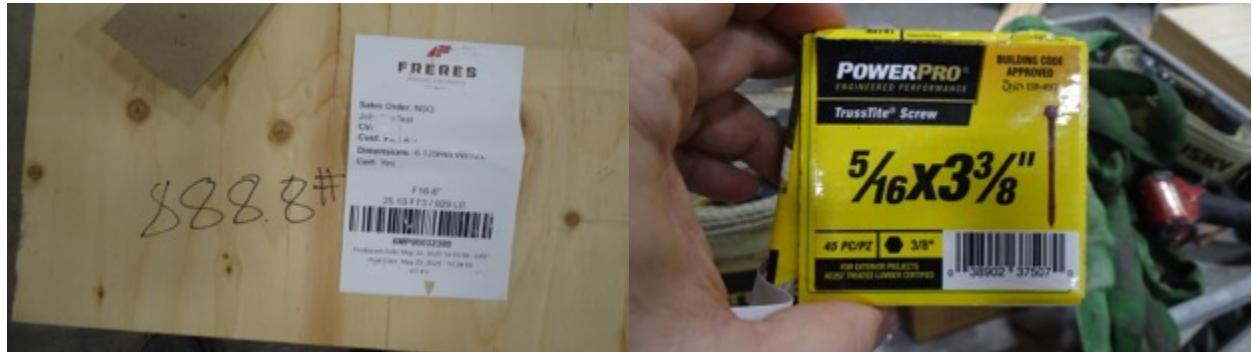
Figure A 1. Component identification showing (a) panel and (b) spline fasteners.

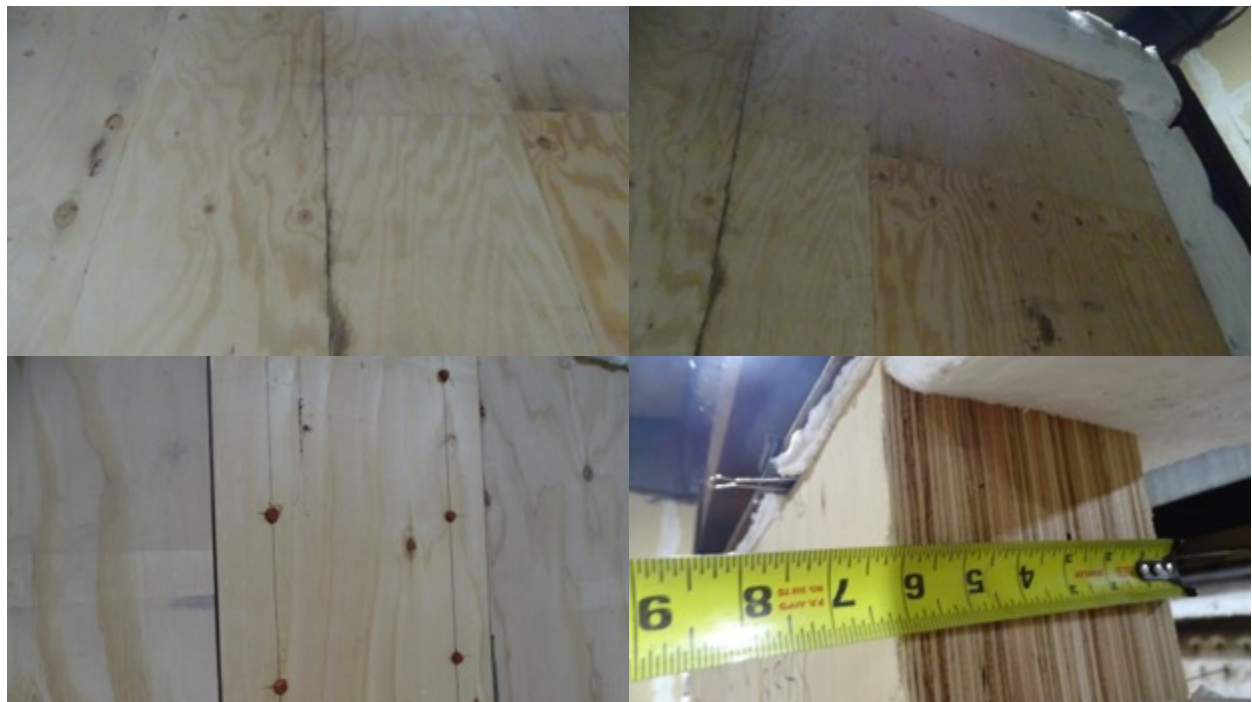
Figure A 2. Construction showing (a) exposed joint, (b) exposed side, (c) spline fasteners, and (d) thickness.

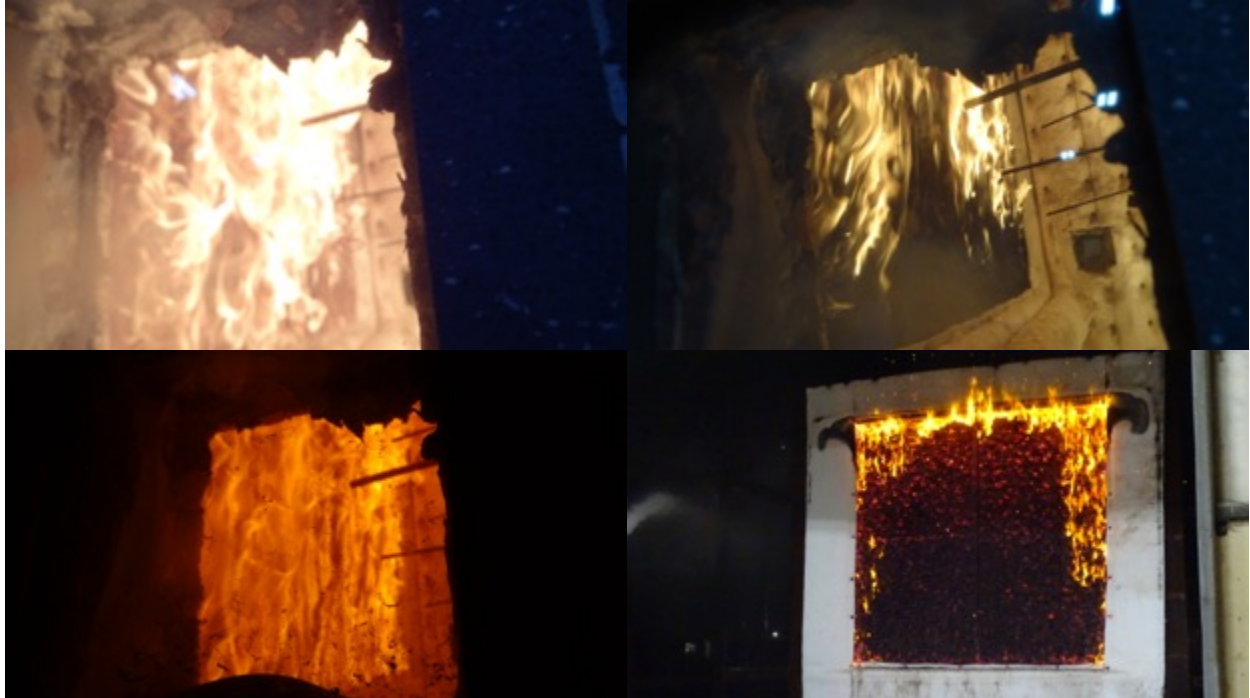
Figure A 3. Additional photos for Test 1 showing (a) 1 min, (b) 5 min, (c) 106 min, (d) before hose.

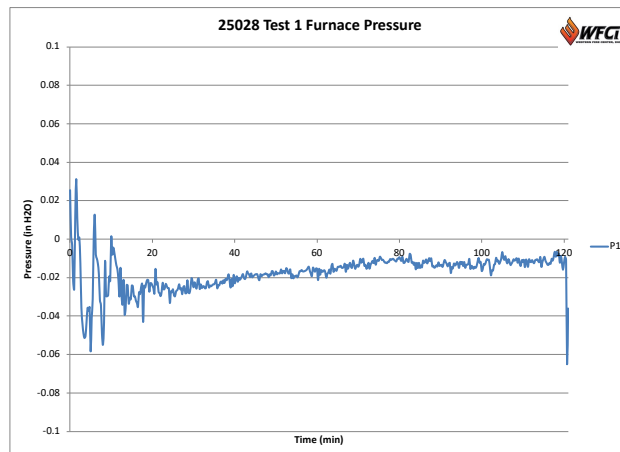
Figure A 4. Furnace pressure for Test 1.

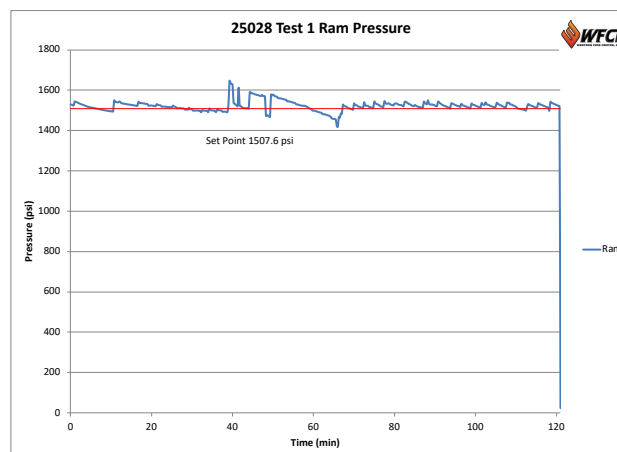
Figure A 5. Ram pressure applied to wall for Test 1.

A superimposed load (80,000 lb_f as indicated by the client as limited by equipment) was applied to the test assembly through a series of hydraulic rams positioned below the wall. The set point for the ram pressure (designed, Table 1) was maintained constant throughout testing. The actual ram pressure was measured during the tests, and the average is shown in Table 1. The load was recalculated and showed a minimal variation (0.9% for Test 1) from the design load. Two linear vertical displacement transducers (LVDT) were placed below each side of the wall assembly, measuring vertical movement of the assembly. Horizontal deflection was also measured at the fire resistance assembly mid-height at each quarter point along the assembly.
